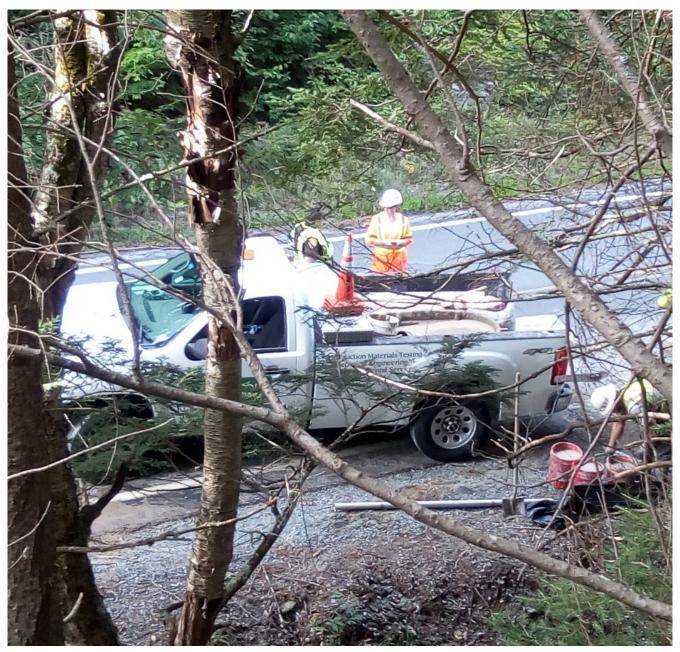
**Photo #4.** Northern Pass inspector (in orange) looks on while S.W. Cole employees load open five gallon buckets of slurry into an open pick-up truck which is also holding an uncovered slurry tub. Location is next to a steep bank down to a stream. This truck drove south down Route 116 and through WMNF before ending where? What happened to the slurry? What would have happened in the event of an accident?

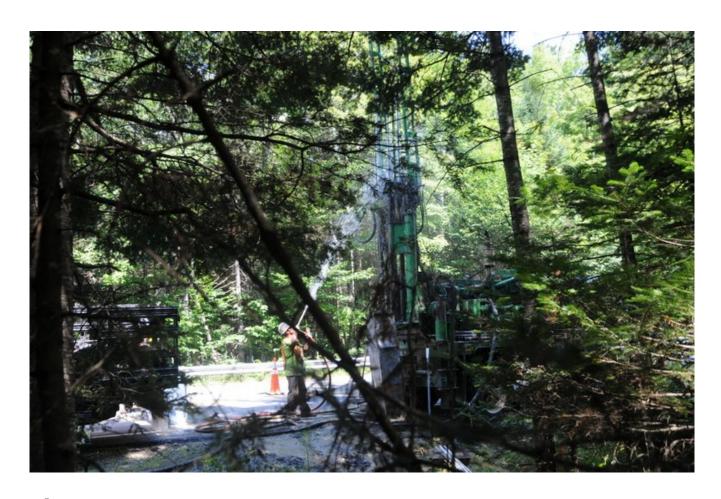
Photo #5.

Cleaning the boring rig near Wildwood Campground public water supply, WMNF, Easton.

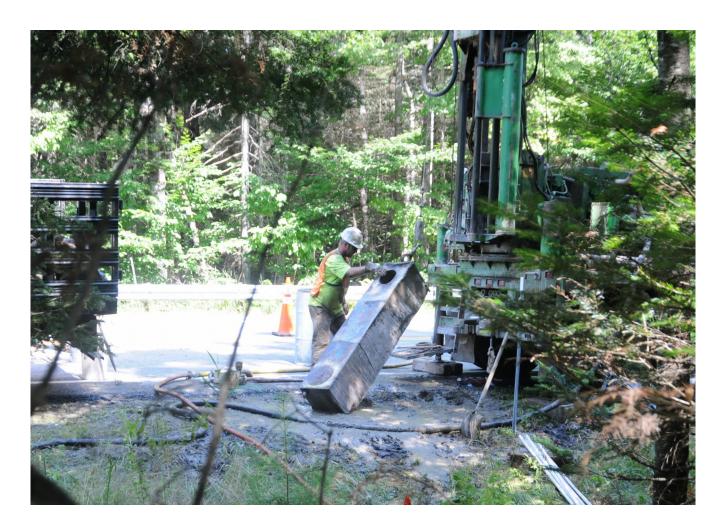
**Photo** #6. Northern Pass contractor dumps slurry onto ground before hosing it into the undergrowth.

This location is next to the public water supply at Wildwood Campground, Easton.

No Safety Data Sheets on site. Does this man know he was working with a male reproductive toxin absorbed through the skin?

Is this Best Management Practices?

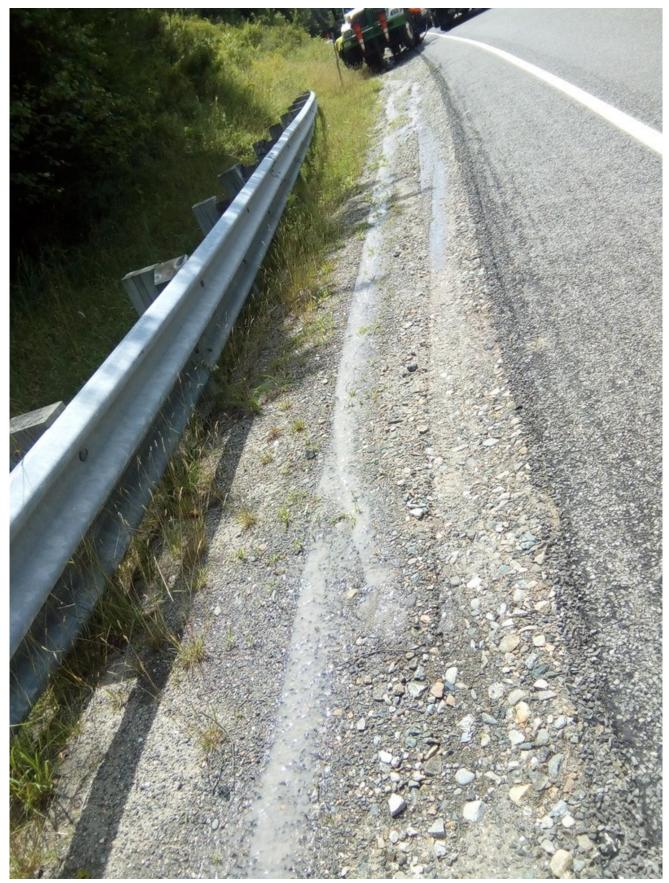
**Photo #7** Slurry tub overflow draining down Route 112, WMNF

**Photo #8** slurry frac-out to Stark Fall Brook, WMNF Woodstock

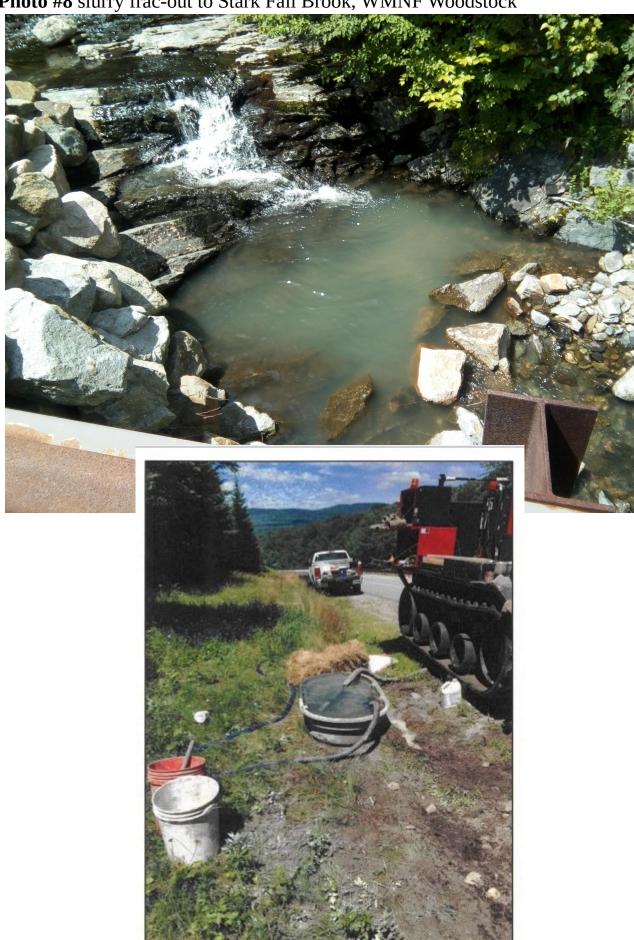
Photograph 1: "Mud bucket" set up for geotechnical borings.

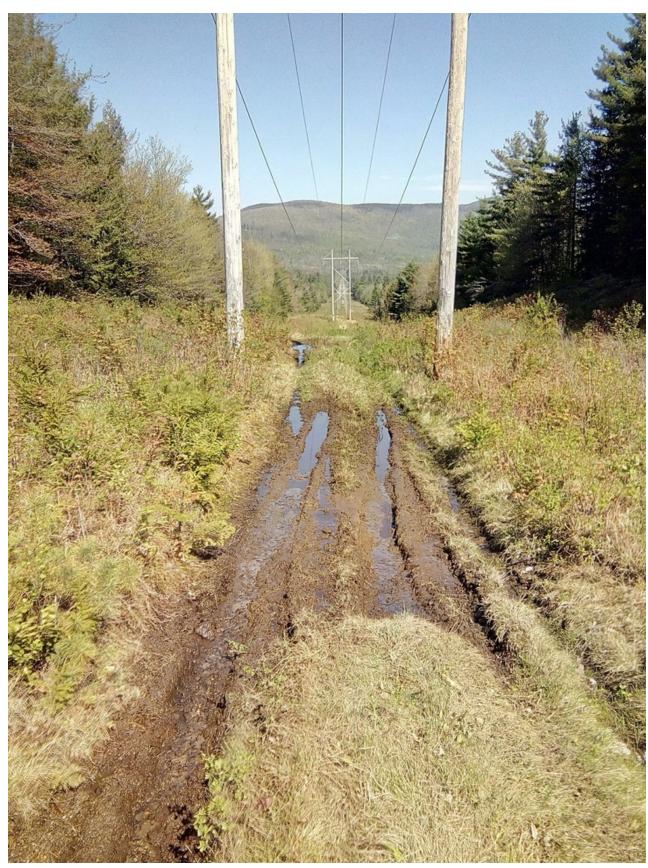
Photo #9, May 2017 Easton

**Photo #10** 2016, Deerfield

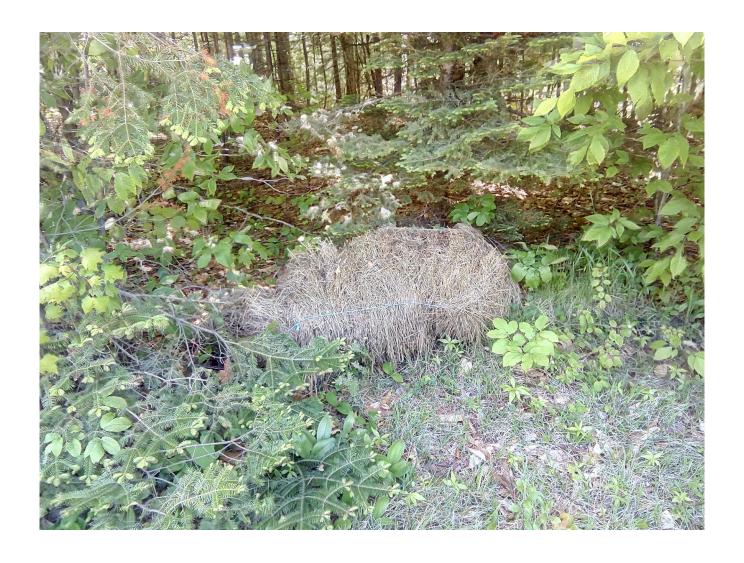
Photo #14, haybale from Stark Falls frac-out site, dumped in woods, WMNF.
